Total Land Subsidence in the Bowie and San Simon Areas, Cochise County
Based on Sentinel-1 Satellite Interferometric Synthetic Aperture Radar (InSAR) Data
Time Period of Analysis: 2.0 Years 01/28/2020 To 01/17/2022

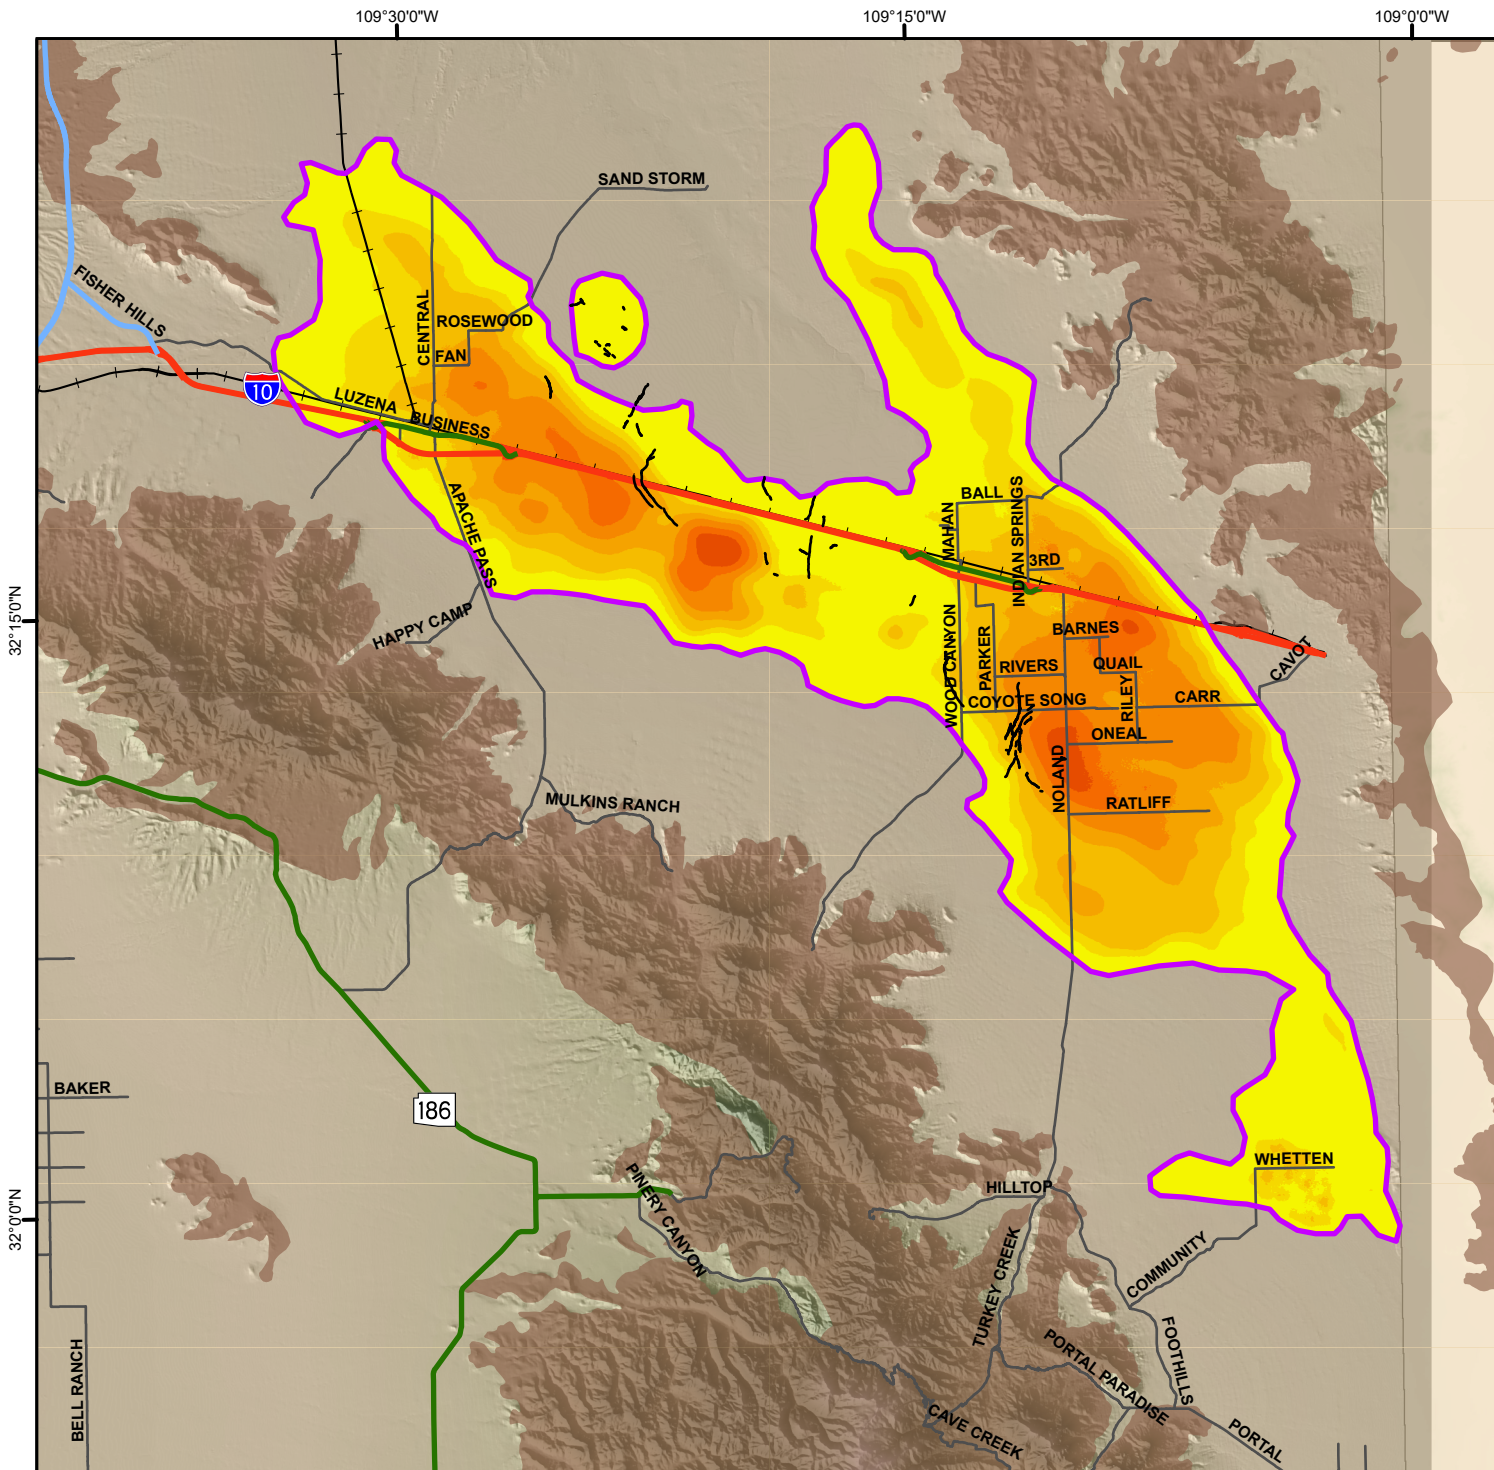
Decorrelation (white areas) are areas where the phase of the received satellite signal changed between satellite passes, causing the data to be unusable. This occurs in areas where the land surface has been disturbed (i.e. bodies of water, snow, agriculture areas, areas of development, etc).
